REPORT DOCUMENTATION PAGE		READ INSTRUCTIONS BEFORE COMPLETING FORM
1. REPORT NUMBER	2. GOVT ACCESSION NO. AD-A105538	3. RECIPIENT'S CATALOG NUMBER
4. TITLE (and Subtitle) Phase I Dam Inspection Report National Dam Safety Program Little Bear Lake Dam (MO 30533) Cape Girardeau County, Missouri		5. TYPE OF REPORT & PERIOD COVERED Final Report

PHASE I INSPECTION REPORT
NATIONAL DAM SAFETY PROGRAM
LITTLE BEAR LAKE DAM - MO 30533
CAPE GIRARDEAU COUNTY, MISSOURI

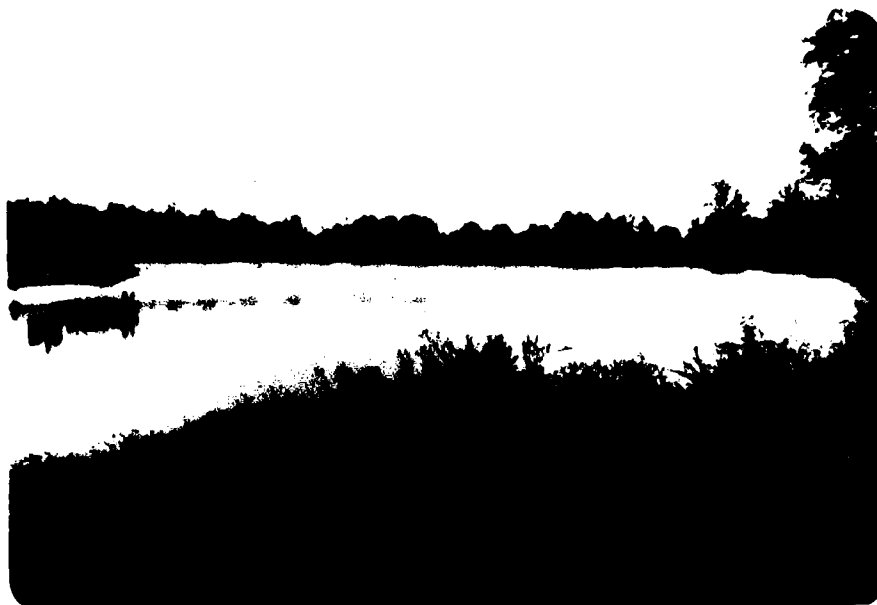
- d. Reservoir Area. The shoreline of the reservoir is well vegetated with no significant erosion. There was no evidence of heavy siltation. Photos 1, 7, 23, 24 and 25 show views of reservoir.
- e. Downstream Channel. The downstream channel from the dam is overgrown with trees and brush. The heavy brush and tree growth could possibly cause backwater effect from spillway flow on the downstream toe of the dam. More detailed information is needed to determine the extent and/or effect it could have on the toe. The channel appears to be stable with no noticeable signs of erosion.

PHOTO NO. 23 - OVERVIEW FROM THE EMERGENCY SPILLWAY. UP-STREAM END OF SPILLWAY IS IN THE FOREGROUND.

PHOTO NO. 24 - OVERVIEW FROM UPSTREAM ON THE RIGHT SIDE.

PHOTO NO. 25 - OVERVIEW FROM UPSTREAM ON LEFT SIDE.
